Johnsonia Shoreline Pilot/Demonstration Project – 2017 Overview

Project Objective

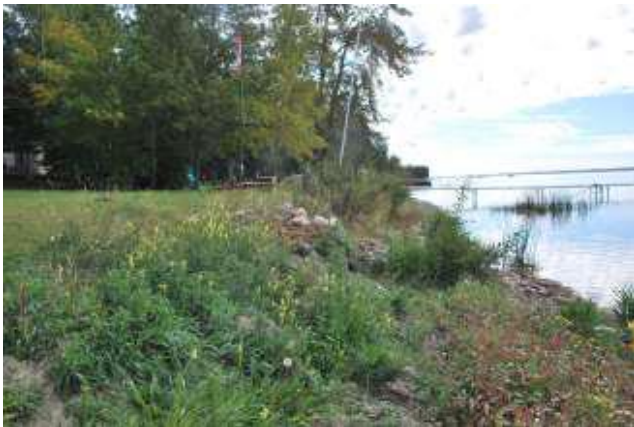
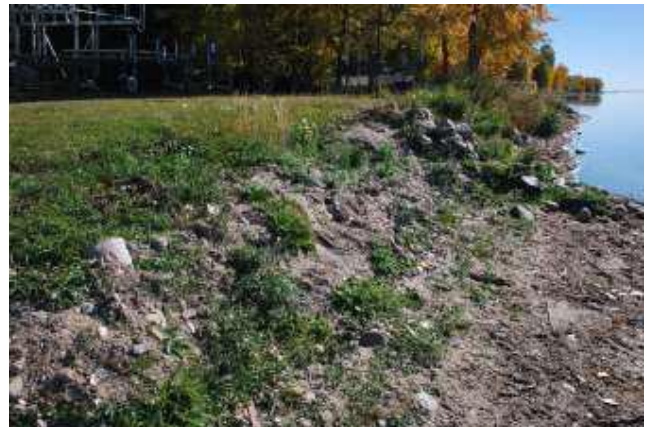
Pre-construction – September 2015

In 2015, the site assessment and selection was completed. In 2016 partnerships and grants secured; permissions requested. Both the AEP and the local council supported the project. There was some vegetation cover but it was sparse and mostly invasive and disturbance plant species. However, there was reed canary grass, shining willow shrub and a seedling aspen tree. These native plants were left alone.

Site Preparation: Started with the removal of the invasive plants. 15 bags were removed by Cows and Fish and PLWA.

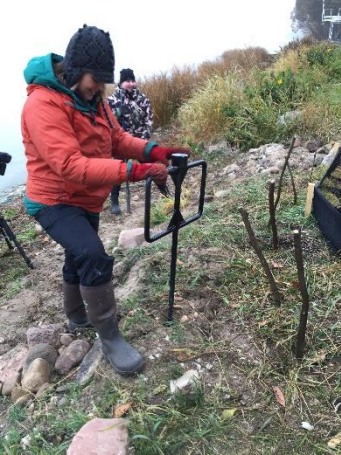
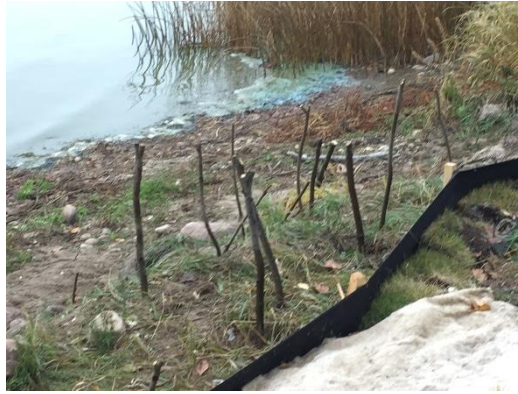
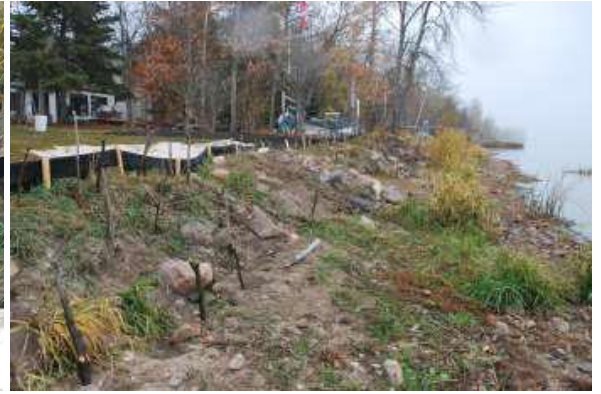
Restoration: Approximately 60 willow cuttings of 3 different types were added to the shoreline along with 2 bundles of willows that were buried Oct 2016. The types of willows were selected because:

There is a gap to allow access to the lake to take the hoist and boat in and out of the lake in the spring and fall.

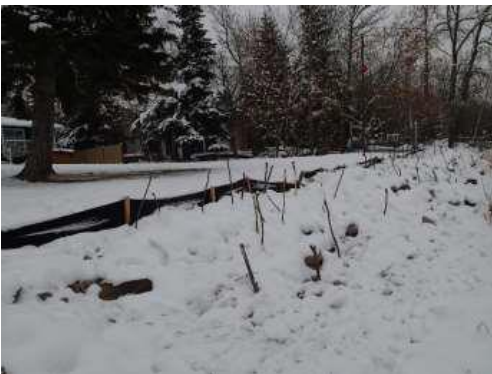
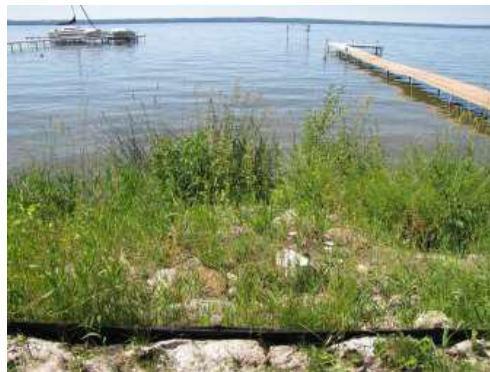
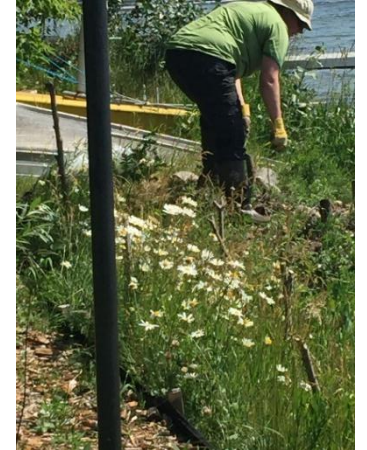
Post Construction – 1 month: A check in November, showed a good snow cover to provide protection and moisture over the winter. **Following summer:** July 2, 2017 (middle picture below) showed a mixture of plants with the first growing season. A good many of invasives were amongst them. A brief assessment was conducted on July 7, 2017 (right picture below) after which many oxeye daisies were dug out and more common tansy clipped.

A number of the willows at the south end do not appear to have taken but the majority have.

Some, invasives like common tansy will require constant cutting back, but the cut back and sunlight deprivation should win out over time. Other invasives were not dug out because any little bit will grow a new plant and compound the problem.

There are also a number of willows that have taken!
