Pigeon Lake Shoreline Assessment Summary Report

Submitted by Watersheds Canada and the Canadian Wildlife Federation.

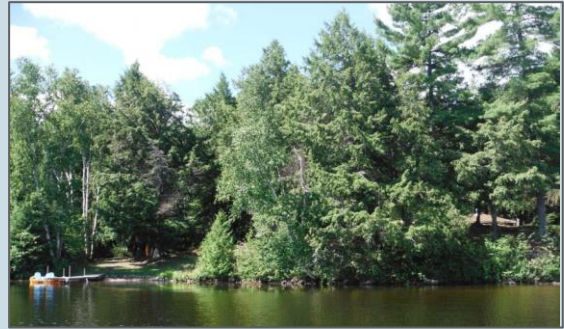
Natural – A healthy buffer of vegetation and/or a natural shoreline of sand or exposed rock that is undisturbed and undeveloped.

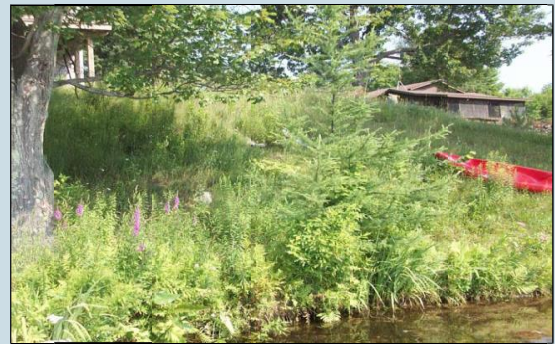
Regenerative – Natural vegetation has been removed in the past, but is in the process of growing back towards a natural state.

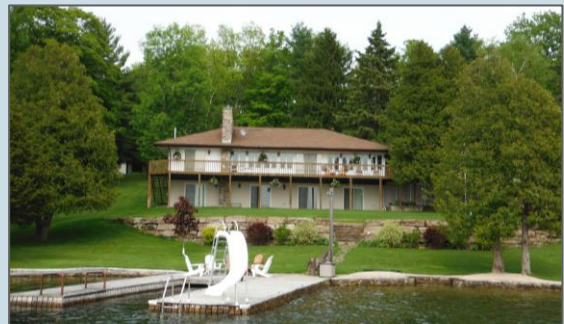
Ornamental – All natural vegetation has been removed and replaced with mowed lawn and other non-native vegetation; structures such as docks, decks, boathouses and boat ramps are predominantly present at the shore.

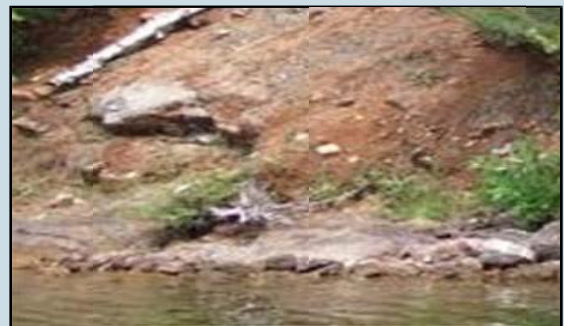
Degraded – Natural vegetation has been lost; soil erosion, undercutting of the bank and/or exposed roots of shrubs and trees are significant.

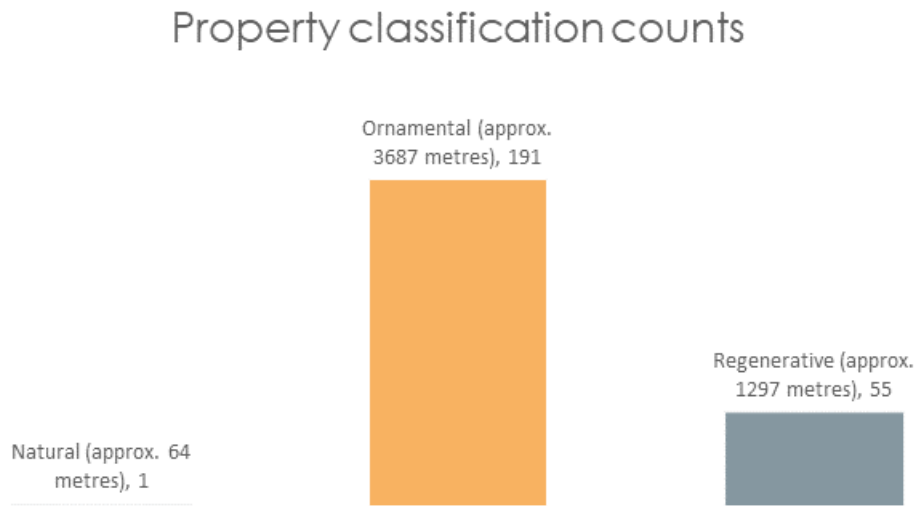
Figure 1 Property Classifications

Figure 1 shows the counts of property classifications on the lake. For example, a property that was 60% Natural, 20% Ornamental and 20% Regenerative would be classified as Natural. Alternatively, a property that was classified as 40% Ornamental, 30% Regenerative and 30% Natural would be classified as Ornamental.

On Pigeon Lake, 1 shoreline property were classified as majority natural, 191 majority ornamental and 55 were considered majority regenerative. It is recommended that shoreline property owners engage in naturalization projects to further decrease the ornamental percentage and increase the regenerative and natural percentages.

This presents an opportunity for residents of Pigeon Lake to increase the overall quality of the lake by maintaining, protecting and enhancing natural shorelines. To restore shorelines to a more natural state, property owners are encouraged to take action. Regenerative properties should also be encouraged to maintain their properties in a natural state by allowing the vegetation on their property to continue to regenerate and grow naturally.

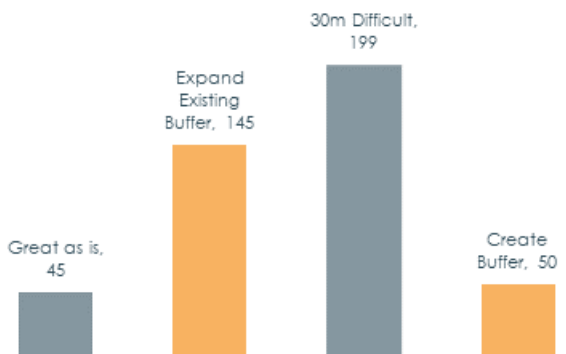
Figure 2 Buffer Recommendations

The survey of Pigeon Lake characterized the types of restoration opportunities that exist around the lake on individual properties. Figure 2 summarizes the number of properties that were assigned a buffer recommendation during the survey. Each shoreline property can receive more than one recommendation.

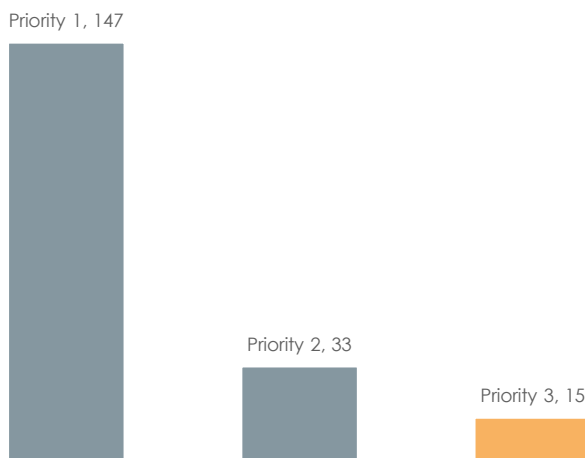
Figure 3 Shoreline Naturalization Property Rankings

Please note that 30m difficult is checked off during the assessment when it is difficult to create or expand an existing buffer. Limitations may be caused by the close proximity of a structure, cliff, rocky terrain/bedrock, or other factors that would make planting a buffer difficult.

In order to determine restoration opportunities on the lake, properties that were assigned a recommendation to expand or create a vegetated buffer were identified and ranked according to their potential for restoration as follows.

Priority 1: Properties that have an ornamental shoreline proportion of greater than 75%, potentially offering an opportunity for significant areas of naturalization.

Priority 2: Properties that have an ornamental shoreline proportion between 50% and 75%.

Priority 3: Properties where the ornamental shoreline proportion is between 25% and 50%. These properties still have areas where there is opportunity for restoration; however they are likely already in a fairly natural condition.

Currently 195 properties would benefit from shoreline naturalization. Of these 195 properties, 147 or 75% of properties are a top priority.

It is recommended for the health of a lake that 75% of the shoreline of each property remains natural, leaving 25% for shoreline development opportunity. Working towards keeping 75% of the shoreline of each property in a natural state will greatly benefit the health of the lake.

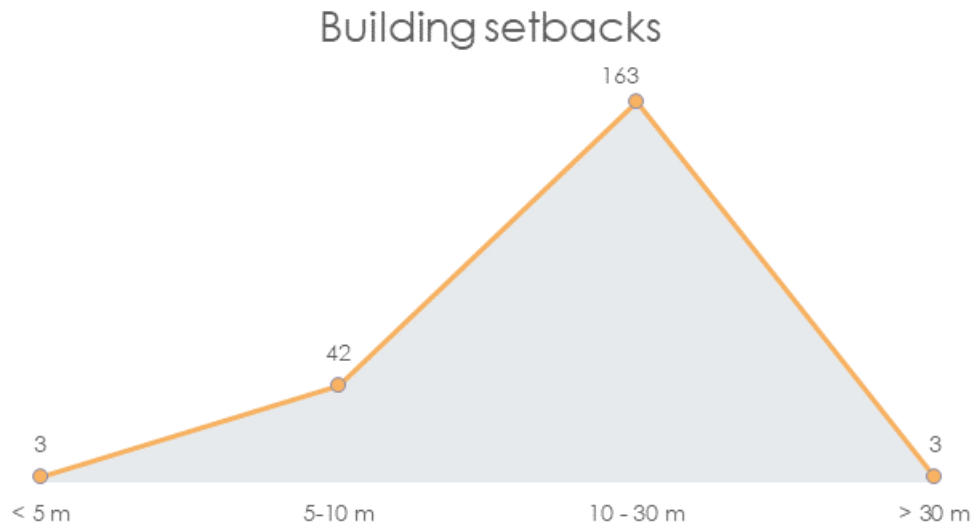
Figure 5 Building Setback Ranges

Shown in Figure 5 is the range of building setbacks for properties on the lake, not including vacant properties, buildings under construction and unidentifiable properties. Building setbacks for shoreline developments should be at least 30 metres from the high water mark; however, older cottage buildings were permitted closer to the

high water mark. On Pigeon Lake, 84% of the properties surveyed were observed to be closer than 30 metres to the shoreline.

A potential area of concern with building setbacks is having septic systems installed close to shore. Regular inspections and maintenance of septic systems can help prevent excess nutrients from entering the lake. Nutrients entering the lake can contribute to eutrophication, resulting in increased aquatic vegetation, low oxygen levels, turbid water and algal blooms. Excess nutrient loading is one of the largest threats to water quality in lakes and rivers; it is everyone’s responsibility to do something to help protect the lake.

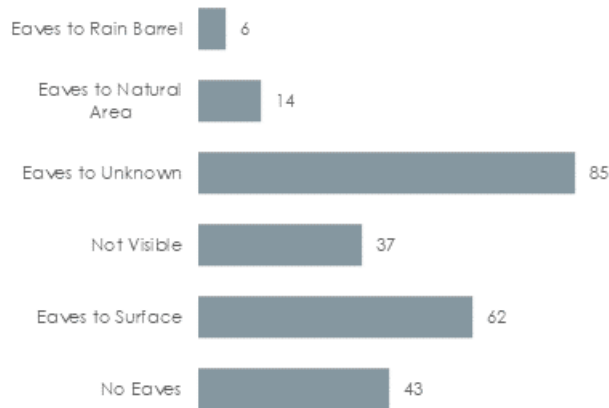
Figure 6 Roof Drainage types around lake

Naturalizing shorelines on properties with near-shore building setbacks would help reduce runoff from entering into Pigeon Lake, which could help reduce potential problems such as algae blooms and loss of oxygen in the water. Property owners can also manage this problem by ensuring they have eave troughs with downspouts directed at natural or stone catch basins or rain barrels, as well as ensuring they have a properly functioning septic to process wastewater before it enters the lake. It is also important to use phosphate free products. Figure 6 shows the types of roof drainage that were recorded from the shoreline assessments.

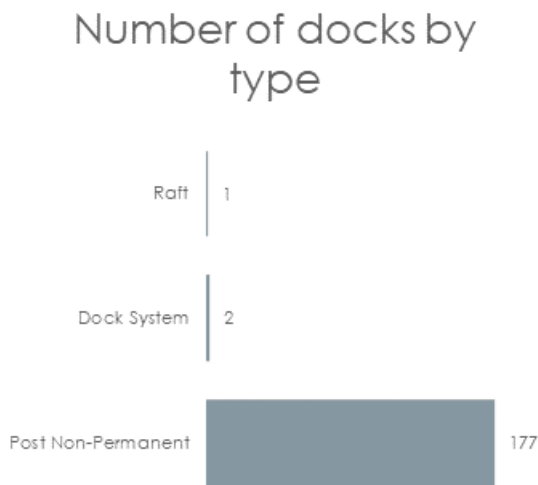
Figure 7 Docks On Lake

Shoreline development is defined as the presence of man-made structures in the water or along the shoreline within three metres of the shore. Development along a shoreline can be done sustainably and in an environmentally sensitive fashion, providing structures are well maintained and kept to a minimal footprint. Figure 7 and 8 illustrate the common structures present on Pigeon Lake.

Floating docks, post docks and cantilever docks are the most environmentally friendly choices, they allow natural water flow, have limited contact with the lake bottom, and reduce the overall potential for disturbance to aquatic life.

In the future, if shoreline property owners need to replace their old or failing solid or crib docks, they could consider choosing post, cantilever or floating docks. By selecting these types of docks, people can reduce the

potential impacts to fish and other aquatic species, which can help protect the overall health of the lake environment.

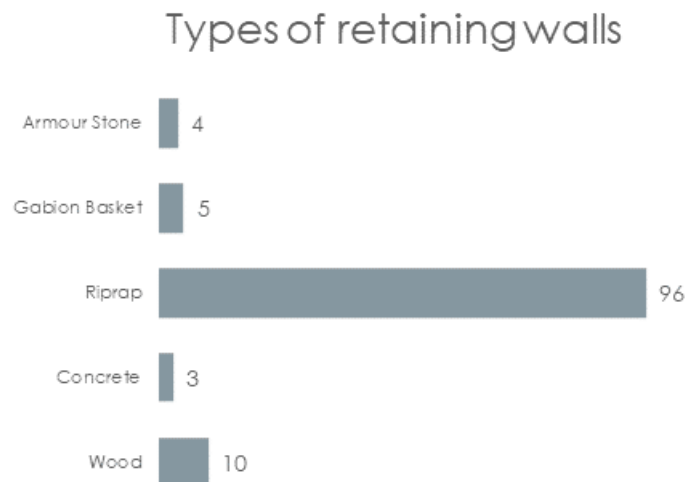
Figure 9 Retaining Walls on Lake

Retaining walls made out of rock, concrete, metal and other materials were once commonly used when it was thought that the only way to combat erosion was to take a hard, aggressive approach. Consequently, people began putting in concrete walls and gabion baskets. These structures only work in the short term to prevent erosion, but they ultimately do much more harm than good. On Pigeon Lake, the number of properties with retaining walls was observed and the results are summarized below in Figure 9.

118 properties on Pigeon Lake, or 48% of the properties assessed have a retaining wall. Of the retaining walls that are present, the most common choice was Riprap. While retaining walls were an option to combat erosion for property owners in the past, we now know about their impact on the natural environment. Wave energy is reflected back from these hard, flat surfaces with the same force as which they strike the wall. This can cause excess turbulence in the water, which scours the sediments from the lake bottom. Solid walls also eliminate shoreline habitat and act as a barrier, preventing wildlife from reaching the water. Although some retaining walls such as rip rap or loose rock have fewer impacts than other retaining walls, shoreline property owners could consider alternative erosion control methods such as planting native vegetated buffers. In the meantime, maintaining vegetation around the wall and allowing new vegetation to establish and grow will help reduce runoff and provide habitat for wildlife. For more information contact the provincial government regarding erosion control and necessary work permit requirements.

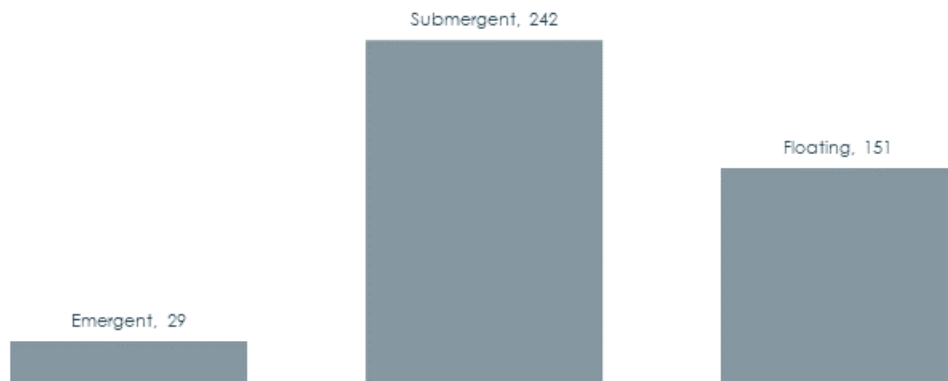
Figure 10 Aquatic Vegetation

On Pigeon Lake, shorelines were surveyed for their presence of aquatic plants. The presence of aquatic plants was further summarized into aquatic vegetation types; emergent, submergent, floating and algal blooms. Figure 10 shows the number of properties on Pigeon Lake that had aquatic plants along their shoreline properties. The majority of aquatic vegetation that was present on Pigeon Lake was categorized as submergent vegetation. Floating vegetation and emergent vegetation were found less frequently on Pigeon Lake, but are still an important part of the aquatic ecosystem; giving habitat to birds, frogs, dragonflies and other wildlife.

When aquatic vegetation is removed, the integrity of the shoreline is lost. This negatively impacts the health of the waterbody by decreasing the quality of the water and reducing biodiversity. Eventually, a waterbody can become unusable, affecting the hundreds of species that rely on it. Fortunately, there are some easy steps that can be taken to help protect and restore your shoreline. By planting native species and allowing natural aquatic vegetation to grow, you can help provide habitat for wildlife to flourish.

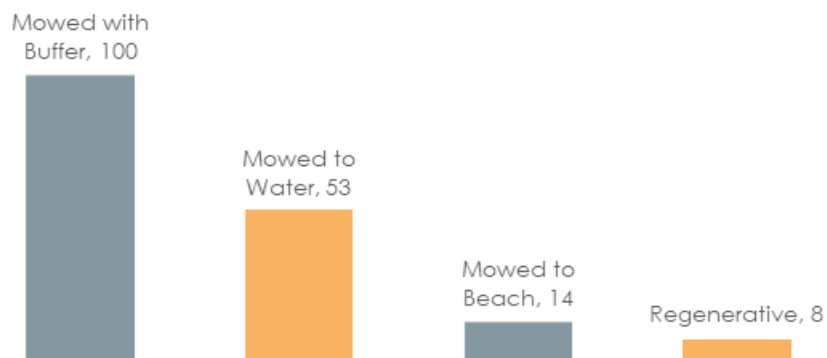
Figure 13 Lawn types

On Pigeon Lake, the number of properties with lawns, either mowed or regenerative, was observed. 21% of properties had lawns that were mowed to the water's edge. When lawn is maintained to the water's edge, natural ground cover and native vegetation are no longer present to slow runoff and allow nutrient filtration. Nutrients, contaminants, pollutants and other harmful substances can be easily carried into the lake by runoff and can harm water quality and local ecological integrity. Lawn grasses also have short root systems and do not bind the soil well, which can lead to problems with erosion and increased sediment deposition.

In areas close to shore, a lawn is generally not a good choice of ground cover. Up to 35% of precipitation can run off a mowed lawn directly into the lake, instead of returning to a natural groundwater source. If shoreline property owners wish to mitigate this, they could consider allowing vegetation to regenerate on its own or by actively planting native trees, shrubs, grasses, or alternative ground cover. The roots of the vegetation will grip the soil which can help prevent erosion. Allowing mowed lawns to regenerate to a more natural state promotes water conservation and protects surface and groundwater resources. Properties with regenerative lawns are encouraged to allow this natural process to continue and to enhance regeneration by planting native trees and shrubs.
